LOWER MAUMEE RIVER RESTORATION DESIGN CONCEPTS

March 2021

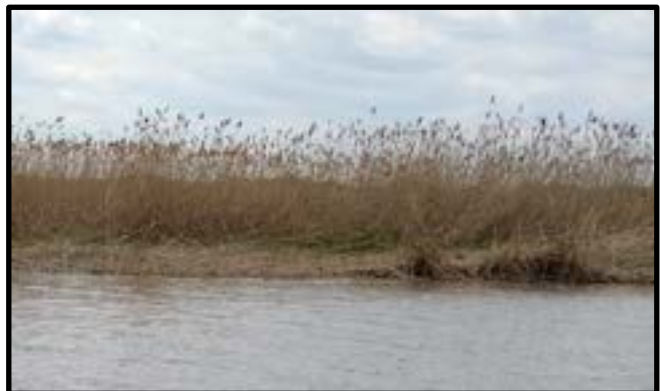
Figure 2. A stand of common reed (*Phragmites Australis*) (photo credit: UT and BGSU).

Invasive plants, such as common reed (*Phragmites Australis*) (Figure 2), are recommended to be removed from the vicinity where native plantings are being installed. These invasive plants may prevent the native plantings from becoming established and do not provide the same quality of habitat for the area. The plants may be removed through either chemical or mechanical means.

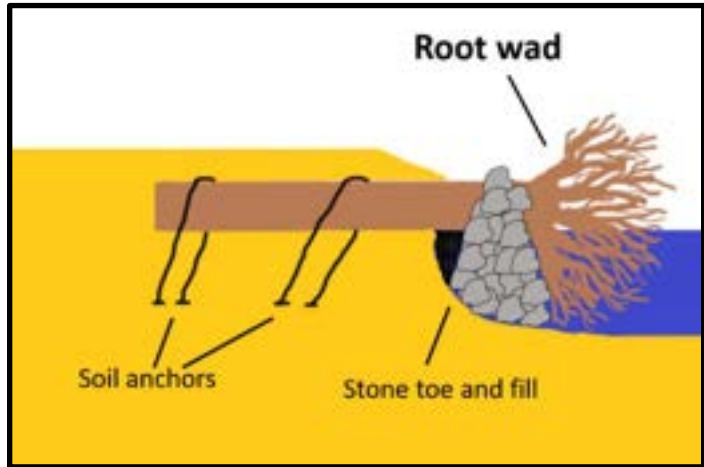
Figure 3: Root wad example (adapted from NRCS, 2008).

Installing root wads (Figure 3) and submerged trees along the shoreline may provide habitat improvements for fish by providing areas with shelter and slower river flows, improve macroinvertebrate populations by providing a food source, and may protect the shoreline from erosion by deflecting the river flow away from the bank. Spacing of root wads and submerged trees is dependent on whether they are being used solely for habitat improvements or also for erosion protection. Erosion protection requires individual root wads and submerged trees to be placed closer together, and the USDA Natural Resources Conservation Service (NRCS) recommends 1 foot of overlap between individual root wads and overlapping submerged trees based on the conceptual plans provided on their Stream Corridor Restoration webpage.

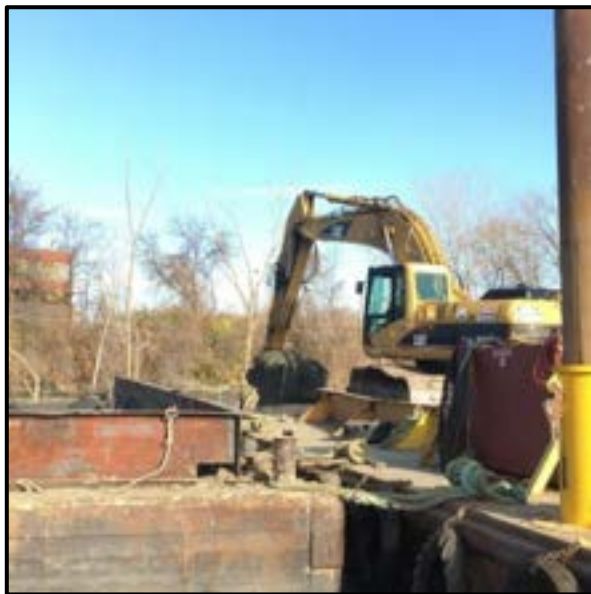
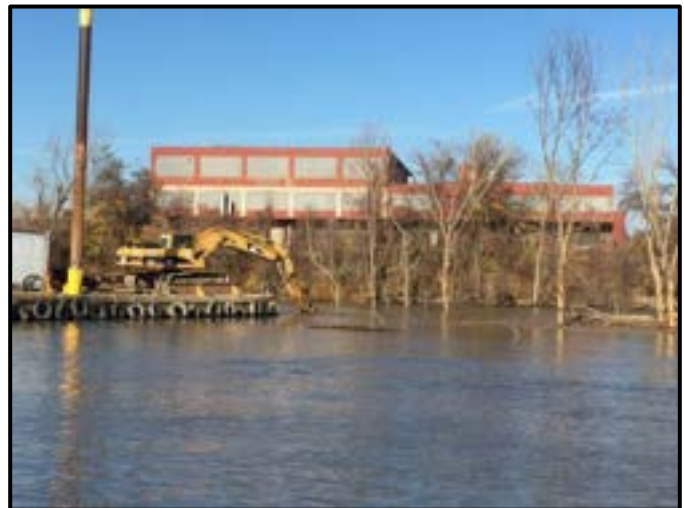
Figure 4: Mechanical dredging in the Maumee River.

Mechanical or hydraulic dredging (Figure 4) may be used to create/enhance shallow water habitat in existing coves of islands by dredging these coves to appropriate water depths to promote submerged aquatic vegetation (SAV) growth. SAV may provide nursery habitat for juvenile fish and a food source for macroinvertebrates (Hintz et al., 2019). However, SAV need to be protected from high flows and waves. To accomplish this, woody palisades or other structures may be placed across the cove entrances as protection against high flows and waves. These woody palisades or other structures may also limit unwanted watercraft access to minimize disturbance to these areas.

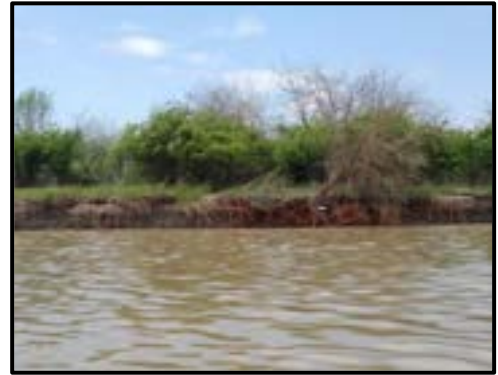
Figure 7. Segment of eroded bank along the southeastern shoreline of Ewing Island (photo credit: UT and BGSU).

Project site #1 encompasses approximately 2,000 linear feet of shoreline along the southeastern side of Ewing Island. This section of the shoreline consists of an eroded bank, which extends approximately 3-4 feet above the water surface depending on water levels, and sparse vegetation (i.e., primarily grasses with a few patches of bushes) on top of this bank (**Figure 7**).

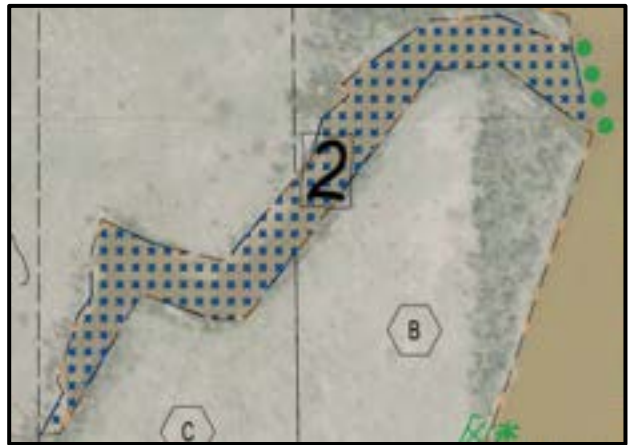
Figure 9. Concept plan for project site #2 (See **Exhibit 2** for additional detail).

It is proposed to dredge this cove (**Figure 9**) with a gradual transition from the shoreline to an approximate depth of 3 feet at average water level (based on recent and projected water levels). This will create shallow water habitat with appropriate water depths for SAV and remove loose sediment that would be more easily resuspended, creating turbid water. SAV may then be planted to provide nursery habitat for juvenile fish and a food source for macroinvertebrates. Deeper water holes may also be dredged and specific substrates (e.g., gravels and cobbles) may be added for additional fish habitat. The entrance of the cove is proposed to be protected with woody palisades, rock sills, or similar structures to protect the SAV from high flows and waves.

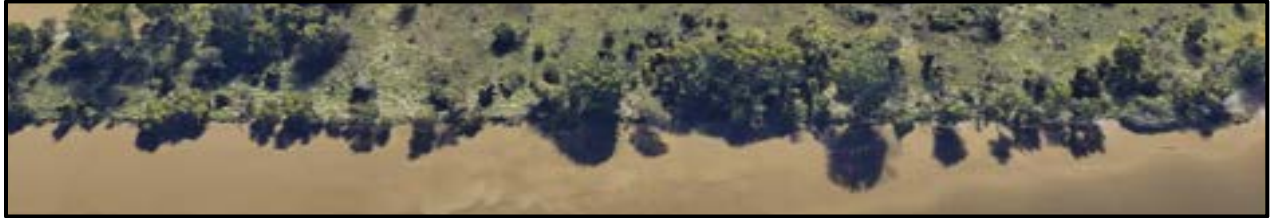
Figure 10. Overview of northern shoreline of Ewing Island (Google Earth Imagery dated 4/29/2018).

Project site #3 encompasses approximately 1,200 linear ft of shoreline along the northern side of Ewing Island. This section of the shoreline contains proportionally more riparian vegetation and woody debris than the eroded southeastern shore; however, this vegetation is spread rather thin, with bare, muddy shoreline making up the space in between stands of trees (Figure 10).

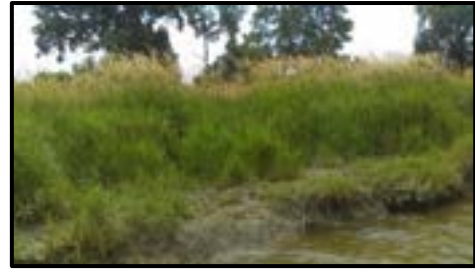
Figure 12. Segment of bank on western shore of Ewing Island (photo credit: UT and BGSU).

Project site #4 encompasses approximately 1,200 linear ft of the eastern shoreline and approximately 710 linear feet of the western shoreline of Grape Island. These sections lack riparian vegetation, woody debris or other shoreline structures, and generally contain only grasses and bare mud (**Figure 12**).

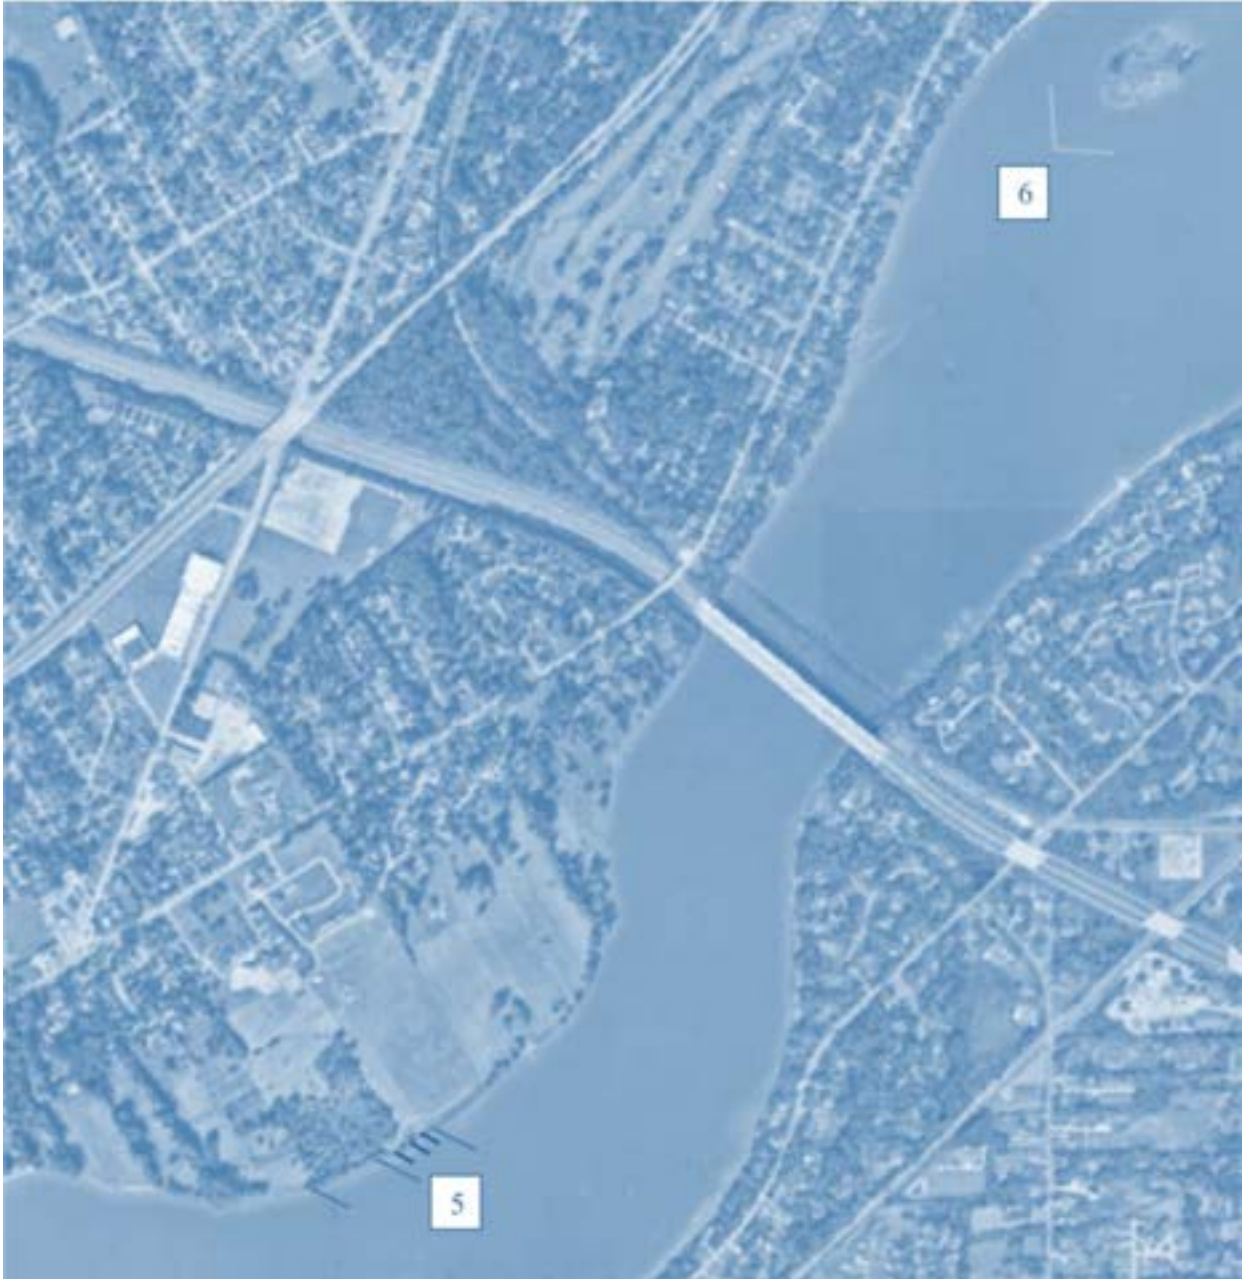
Two main channel projects are proposed to occur between Audubon Islands and Grassy Island, as identified on **Exhibit 3**.

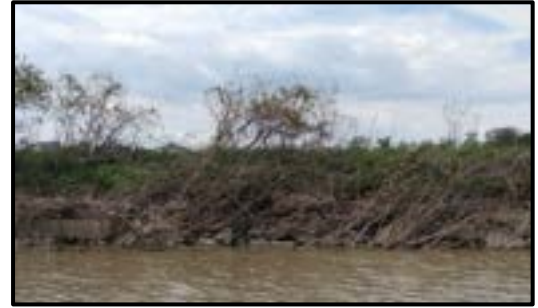
Figure 14. Shoreline of project site #5 covered in woody debris from shrubbery (photo credit: UT and BGSU).

Project site #5 consists of a section of shoreline owned by the city of Maumee (Parcel No. 3602039), which is located south (upstream) of the I-80/I-90 Ohio Turnpike in Maumee and approximately 12.5 miles upstream of the river mouth into Maumee Bay. The shoreline in this area is mostly hardened with rip-rap, with some shrubbery growing just behind and among the rip-rap. In some areas, this shrubbery completely covers the rip-rap (**Figure 14**).

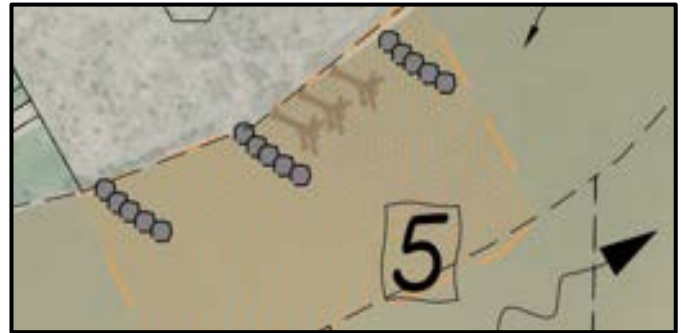
Figure 15. Concept plan for project site #5 (See **Exhibit 3** for additional detail). (photo credit: UT and BGSU).

It is proposed to install rip-rap wing dikes and submerged trees along the shoreline to augment fish and macroinvertebrate habitat in this area (**Figure 15**). These wing dikes may extend a few hundred feet out from the shore and could be notched to provide additional habitat variety. Cobbles may also be placed on the sides of the dikes for sturgeon spawning. Design of this project site will include hydrologic and hydraulic (H&H) modeling to evaluate the impacts these dikes may have on flows in nearby sections of the river.

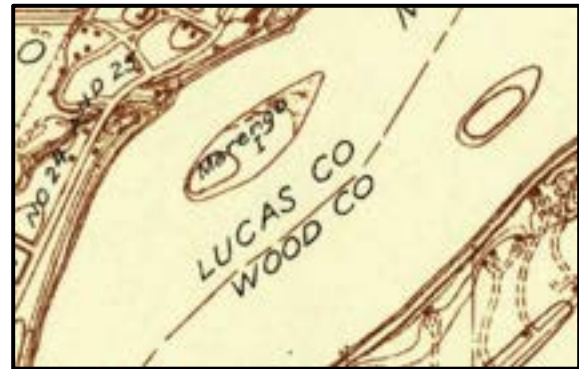
Figure 16. USGS Historic Map of Marengo Island (Adapted from USGS, 1935).

Project site #6 is located north (downstream) of the I-80/I-90 Ohio Turnpike by Marengo Island, an approximately 3.5-acre island located 10.5 miles upstream of the river's mouth into Maumee Bay in Toledo. Based on a historic map from 1934 (Figure 16), Marengo Island once had a larger footprint.

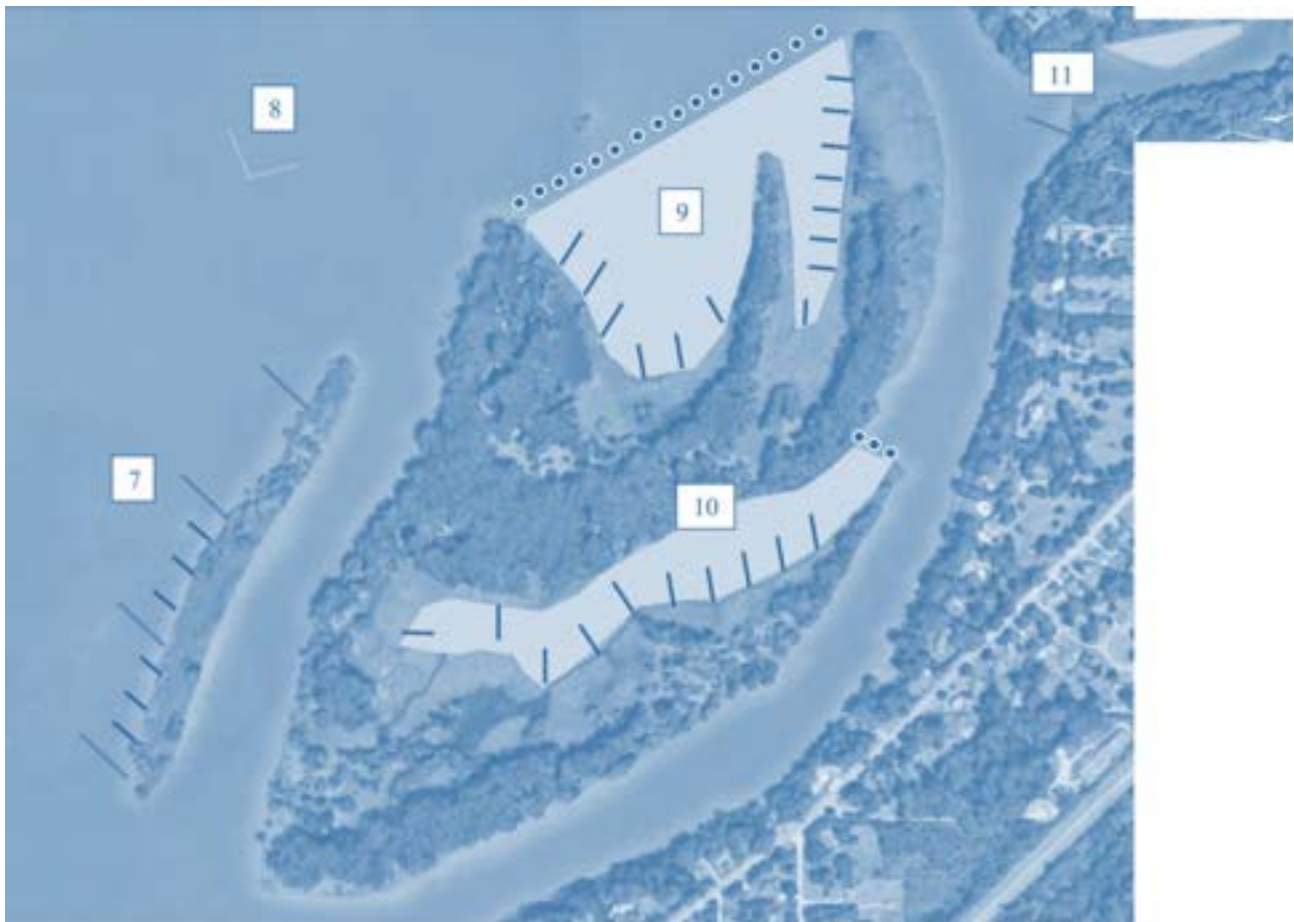
Five project sites are currently proposed for this area, as identified on **Exhibit 4**.

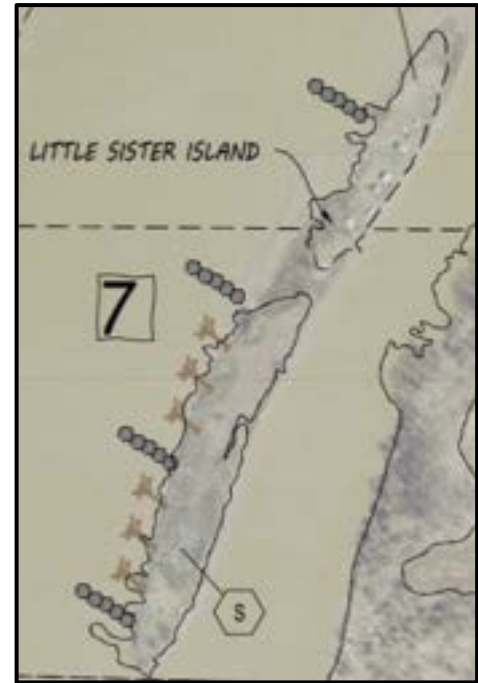
Figure 18. Concept plan for project site #7 (See **Exhibit 4** for additional detail).

It is proposed to install rip-rap wing dikes and submerged trees along the shoreline to augment fish and macroinvertebrate habitat in this area (**Figure 18**). These wing dikes may extend a few hundred feet out from the shore and could be notched to provide additional habitat variety. Cobbles may also be placed on the sides of the dikes for sturgeon spawning. Design of this project site will include hydrologic and hydraulic (H&H) modeling to evaluate the impacts these dikes may have on flows in nearby sections of the river.

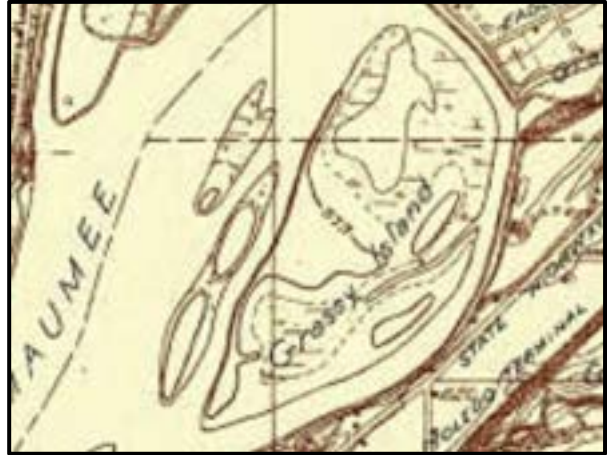
Figure 19. USGS Historic Map of Marengo Island (Adapted from USGS, 1934).

Project site #8 is located immediately northwest of Little Sister Island. Based on a historic map from 1934 (**Figure 19**), there was once an island in this area of the river. As a result, it was recommended to re-establish this island by Hintz et al. (2019).

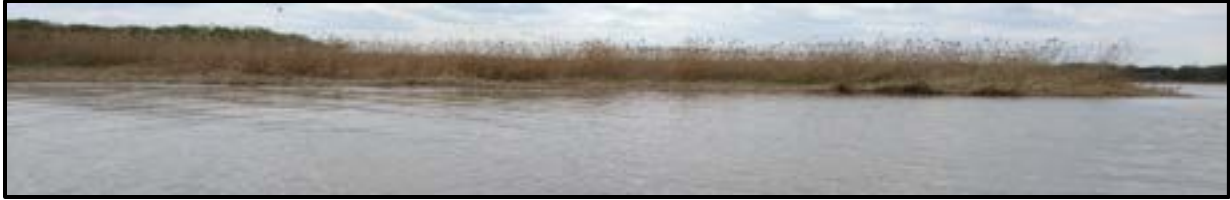
Figure 21. Common reed (*Phragmites Australis*) stands on northernmost tip of Grassy Island (photo credit: UT & BGSU).

Project site #9 encompasses an approximately 970,000 square foot cove on the northern side of Grassy Island. The shoreline surrounding the northern cove of Grassy Island is almost exclusively emergent vegetation and is dominated by stands of common reed in some stretches (**Figure 21**).

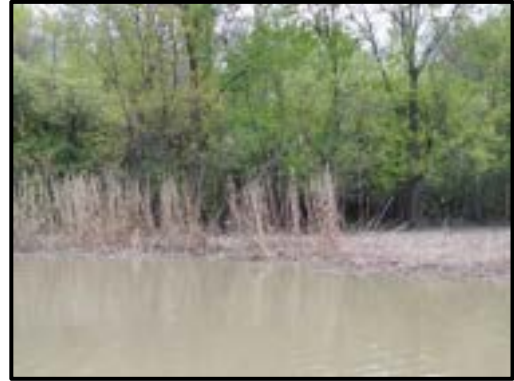
Figure 24. Common reed (*Phragmites Australis*) stands near the mouth of Grassy Creek (photo credit: UT and BGSU).

Project site #11 is located at the confluence of Grassy Creek and the Maumee River. It was observed by UT and BGSU that Grassy Creek is prevented from scouring sediments at this confluence by the strong currents of the Maumee River, and common reed is prevalent in this area (**Figure 24**).

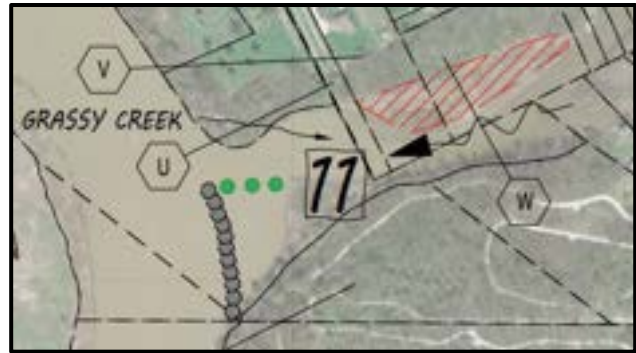
Figure 25. Concept plan for project site #11 (See **Exhibit 4** for additional detail).

Construction of a dike near the confluence of Grassy Creek and the Maumee River is proposed to promote scour in Grassy Creek (**Figure 25**). This dike is proposed to follow the existing shoreline of the Maumee River immediately upstream of the confluence with Grassy Creek and is anticipated to be a few hundred linear feet in length. The area on the Grassy Creek side of this dike would be protected by woody palisades or another structure to prevent debris from accumulating in this area. SAV may be planted in this area for additional fish habitat or dredged material may be placed here to create additional upland habitat.

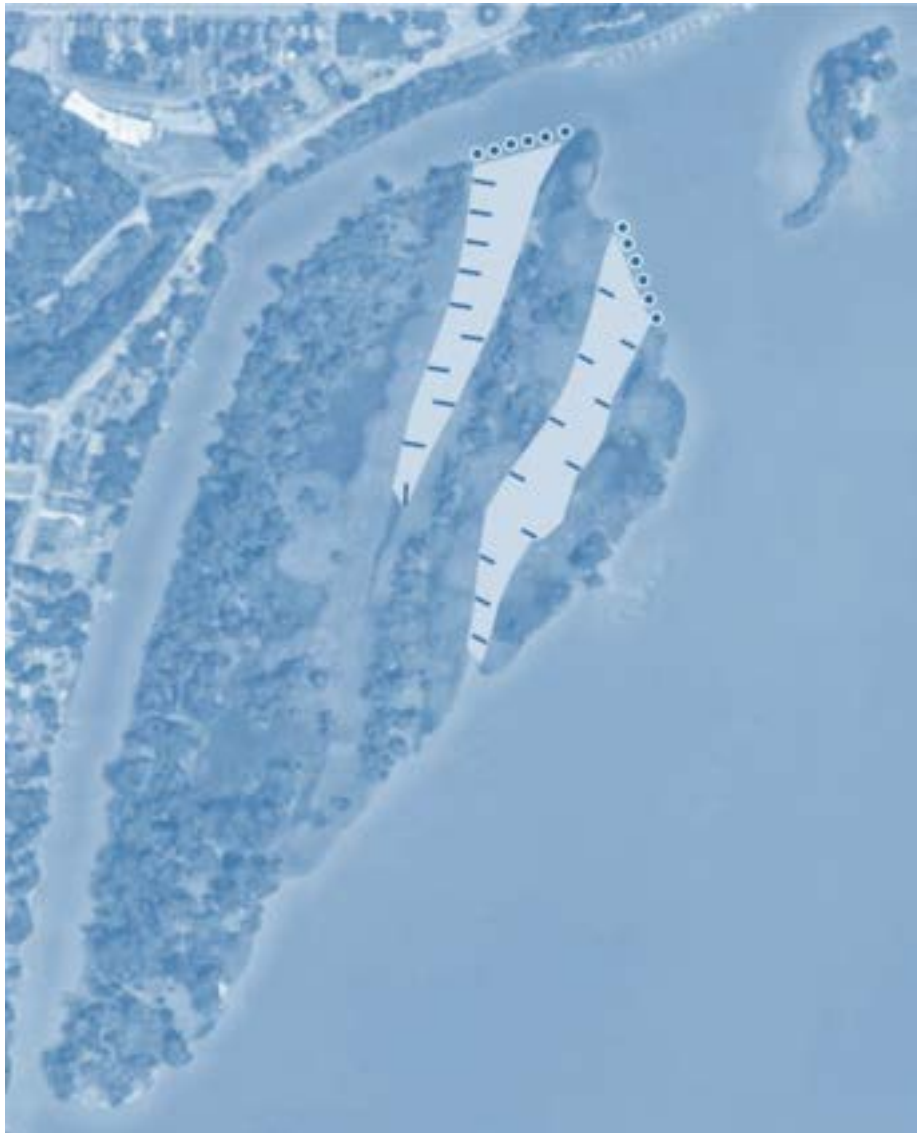
One project site is currently proposed for this area, as identified on **Exhibit 5**.

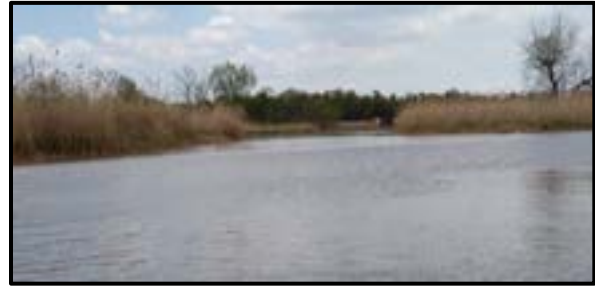
Figure 26. Common reed (*Phragmites Australis*) along the shoreline of the cove between Horseshoe Island and a detached portion of the island (photo credit: UT and BGSU).

Project site #12 includes two coves on the northern side of the Delaware/Horseshoe Complex, which together encompass approximately 420,000 square feet. The shoreline around these coves mostly consists of emergent wetland vegetation, much of which is dominated by common reed (**Figure 26**).

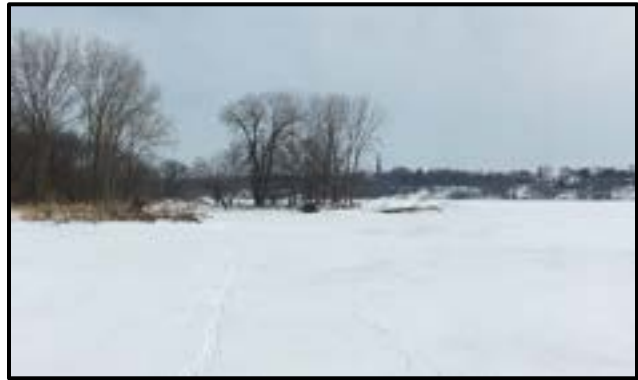
Figure 28. Ice in the Maumee River near Audubon Islands.

During the design phase, two important considerations are the ice flows and seiche events experienced in this stretch of the Maumee River (**Figure 28**). The ice flows may exert strong shear forces on the restoration features and therefore present a risk for damage after construction. The seiche events result in significant daily variations in water levels and some of which cause the river to flow upstream, which may affect the performance of some restoration features (e.g., chevron dikes, dredged coves, etc.). Planning for these events during the design phase will minimize damage caused by these events and the resulting required maintenance.

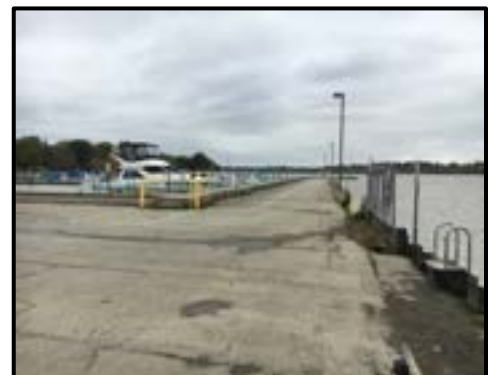
Figure 29. Potential river access from Rossford Marina.

The main challenges for construction are accessing the project sites and performing the work on water. Except for project site #5, it is anticipated that access to all project sites will require the use of watercraft. Multiple river access locations are available in the vicinity of the project sites (**Figure 29**), but all may not be suitable for use during construction due to shallow water levels in these areas or narrow and tight access roads. Therefore, contractors may need to travel from further downstream for a suitable launch location. In addition, it is uncertain if the islands will be capable of supporting the necessary equipment for constructing these projects

so it is likely that the work will need to be completed from a barge. This may require the contractor to utilize a larger barge that will be stable in the river while the equipment is operating.

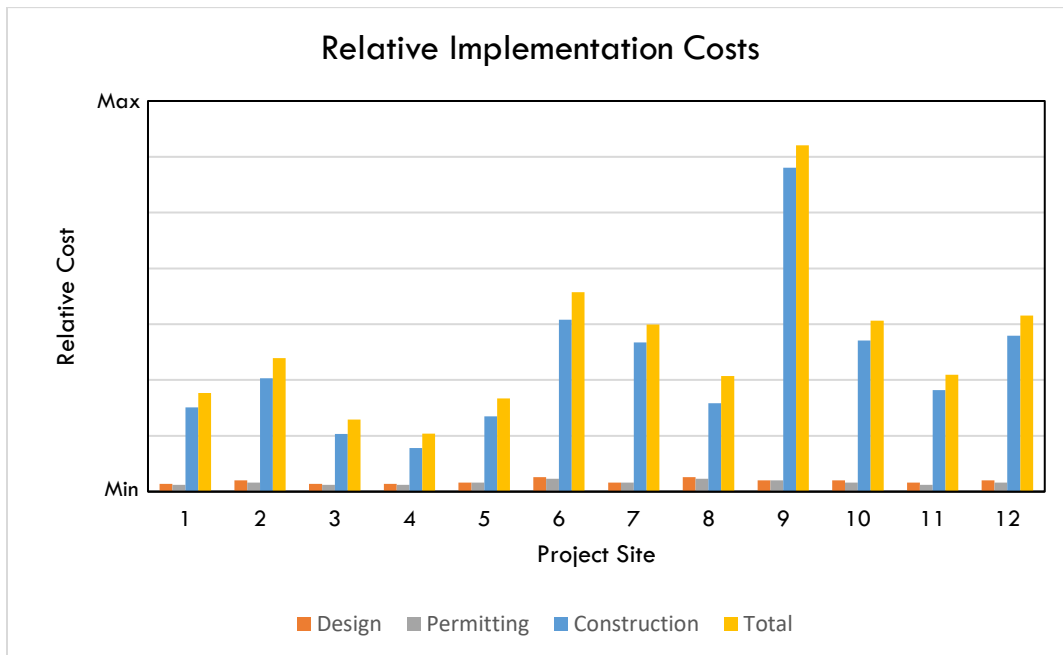
Graph 1: Relative design, permitting, construction, and total implementation costs for each project site.

Graph 1 shows the relative design, permitting, construction, and total costs for each of the project sites. This graph clearly shows that project site #9 is anticipated to have the highest relative cost and project site #4 the lowest. Also, the anticipated costs are primarily associated with construction, and the design and permitting costs are relatively similar for each project site.
