# Crosby Lakes and Hill Ditch Lake and Stream Restoration Project

## Post-project Fact Sheet

Fall 2014

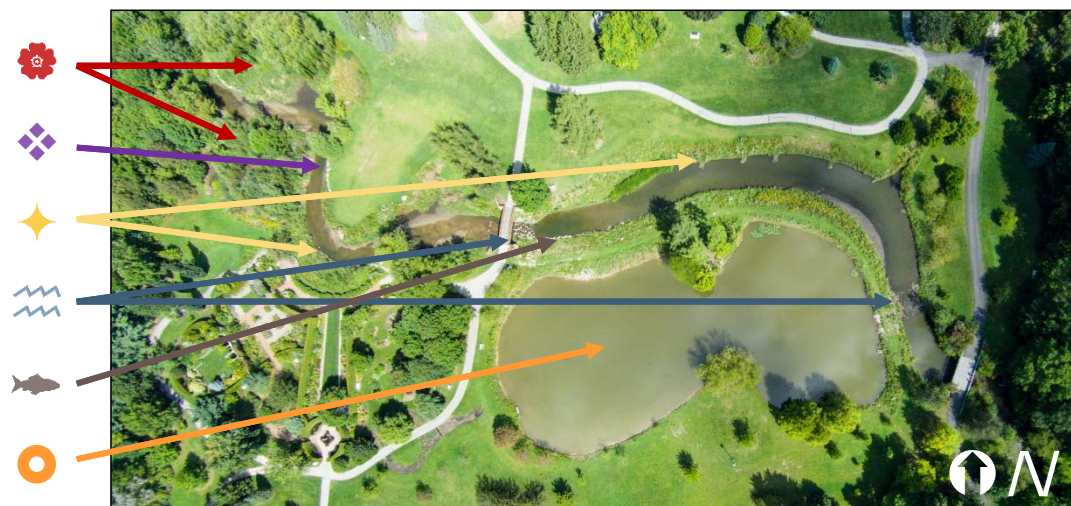
- **Wetlands** [🌸] - Upstream of the Formal Garden and wooden bridge the smaller Crosby Lake area has been restored to wetlands with a stream running through them. The wetlands provide opportunities for rare species of plants and help to store excess storm water. This area can be viewed from a series of sandstone boulders that serve as access and observation for both the wetland and stream.

- **Channel Bank Protection** [💎] – Upstream of the wooden bridge and in front of the Formal Garden are a series of boulders that were placed to create a new stream bank. This narrows the stream to a more natural size; helping to restore natural stream function. The area between the new bank and Formal Garden serve as a mini wetland, visually softening the steel sheet-pile wall, providing an area for wetland flowers and plants and providing more flood water storage area. This area can also help to remove suspended sediment in floodwaters

- **Bendway Weirs** [★] – Along with the channel bank protection and throughout the stream you may see either large single stones jutting out in the water like fingers or further downstream similar objects are visible but composed of multiple smaller stone. These features help to direct the streams flow towards the center of the channel to reduce bank erosion. The bendway weirs are quite effective, though barely noticeable in most cases. Their effects can easily be seen even after a small storm.

- **Rock Riffles** [🌊] - All rivers, streams, and ditches flow downhill, but this change in elevation can be hard to see, especially in northwest Ohio. Once the dams were removed, the change in elevation had to be mediated to prevent erosion. Three rock riffles were built to help ease the elevation change downstream. The riffles are located roughly in the positions of the former dams with one in between. The riffles allow fish to easily move up and downstream. This movement was not possible when the dams were in place. The riffles have also added the sound and visual element of moving water to the garden, something many people enjoy.

- **Stone Fish Ledges** [🐟] – These ledges can be seen just downstream of the wooden bridge and rock riffle. The large rocks overhang the water and provide an open space below them. Fish and other aquatic organisms can use these open areas as cover to protect themselves from predators above, such as Great Blue Heron often seen at TBG. Similar to an undercut stream bank in a natural stream, these ledges provide shade and cool water. This undercut bank and rock ledge offer the protection, but don't contribute to soil erosion.

- **Crosby Lake** [🟠] – The larger Crosby Lake was dredged and deepened to it's original designed depths. The eroded banks were re-graded and vegetated to hold soil in place. Much of the lake has shallow areas along the edges where emergent plants such as lotus have been planted.
