Summary of Concepts at Selected Sites

Lower Maumee River Habitat Restoration Projects

Great Lakes Restoration Initiative (GLRI)
Economy Act (31 U.S.C. 1535) for USEPA
Prepared by U.S. Army Corps of Engineers

January 2022

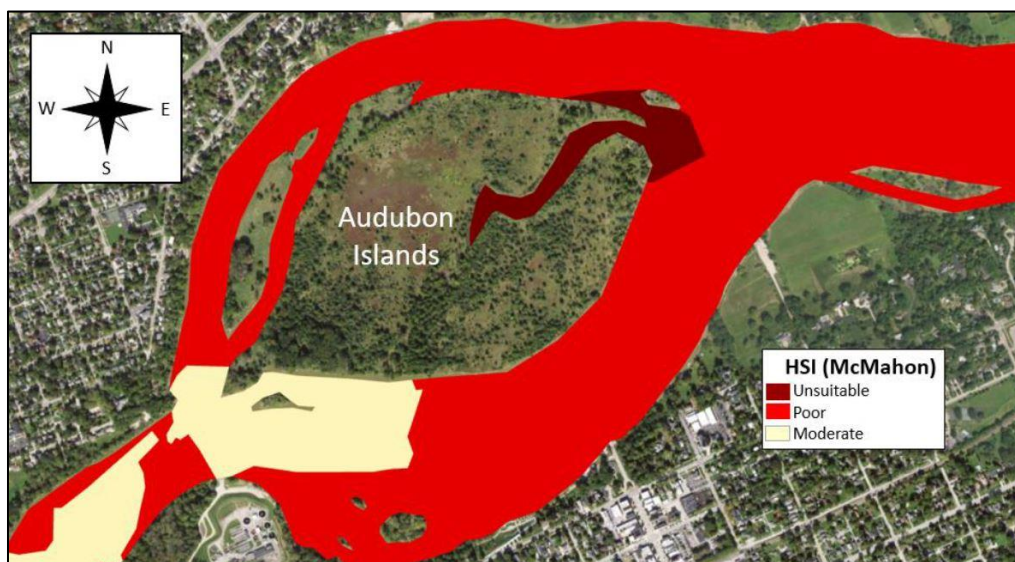
Figure 9: Output of McMahan HSI model for walleye spawning around Audubon Islands at median spring discharge.

Based on the HSI model outputs, it is assumed that walleye spawning habitat is present throughout the Audubon Island complex. All the proposed in-water preliminary restoration designs around the Audubon Islands complex, except for the preliminary cove designs, could potentially modify existing walleye spawning habitat. Therefore, the University of Toledo (UT) recommends avoiding any restoration activity that could substantially modify this spawning habitat.

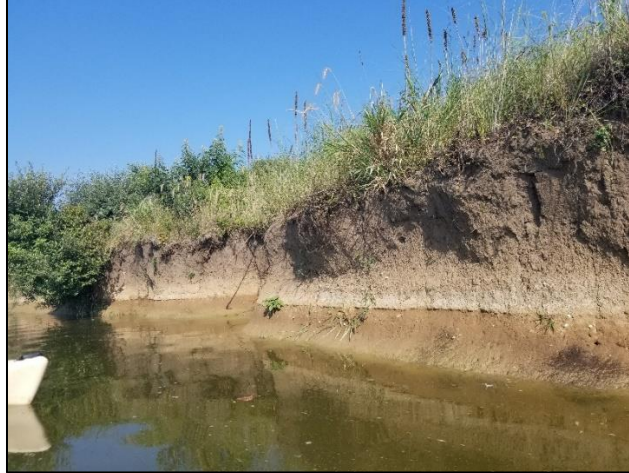
Figure 12: Bank erosion along Ewing Island.

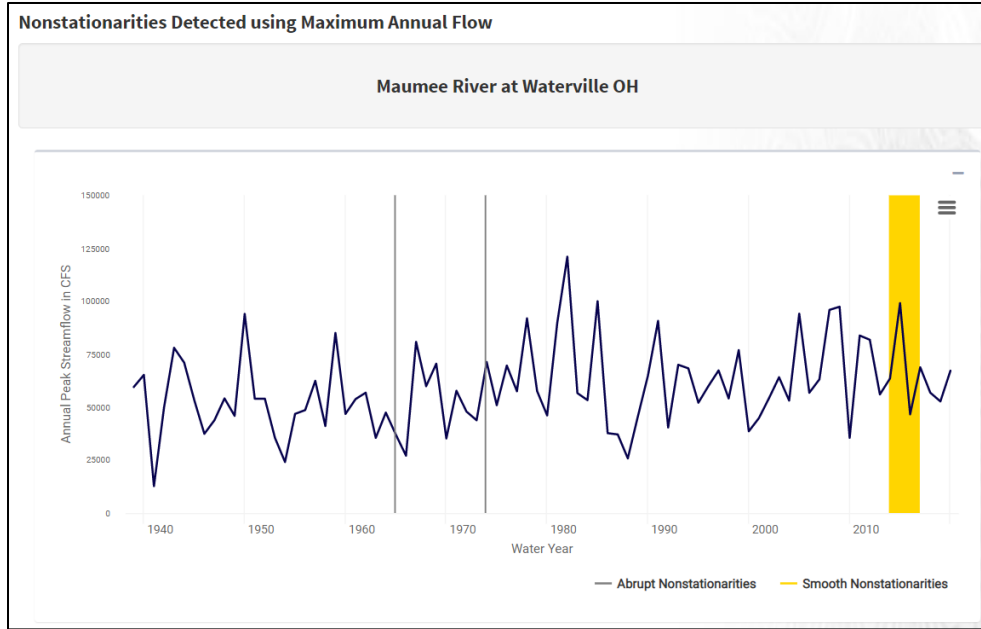
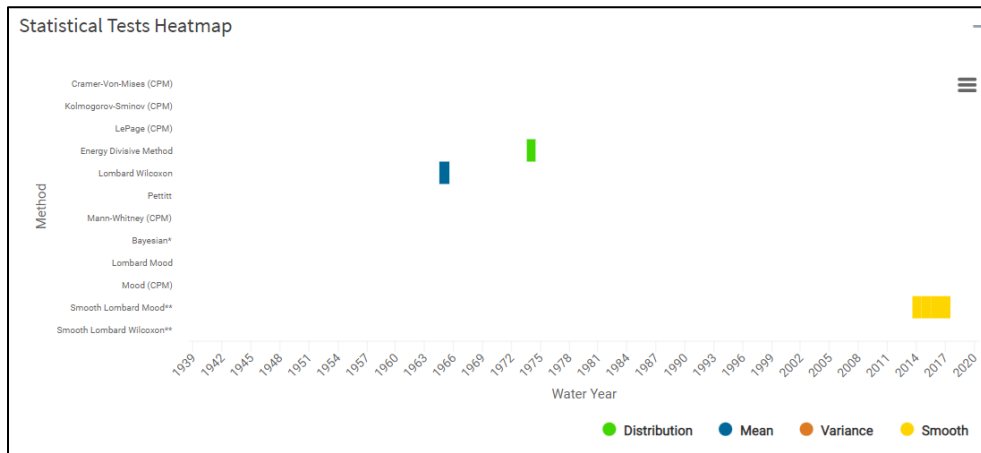
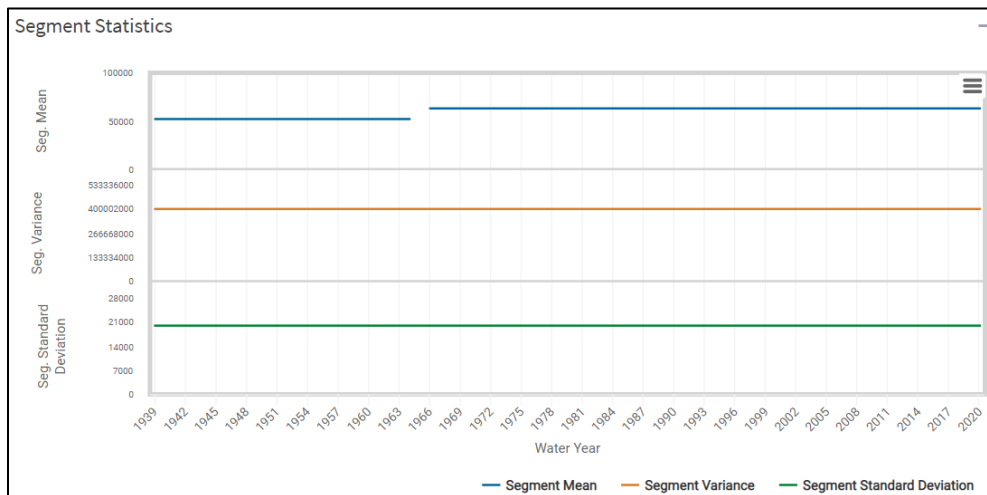
Figure 16. Non-Stationarity Detection Tool Results.

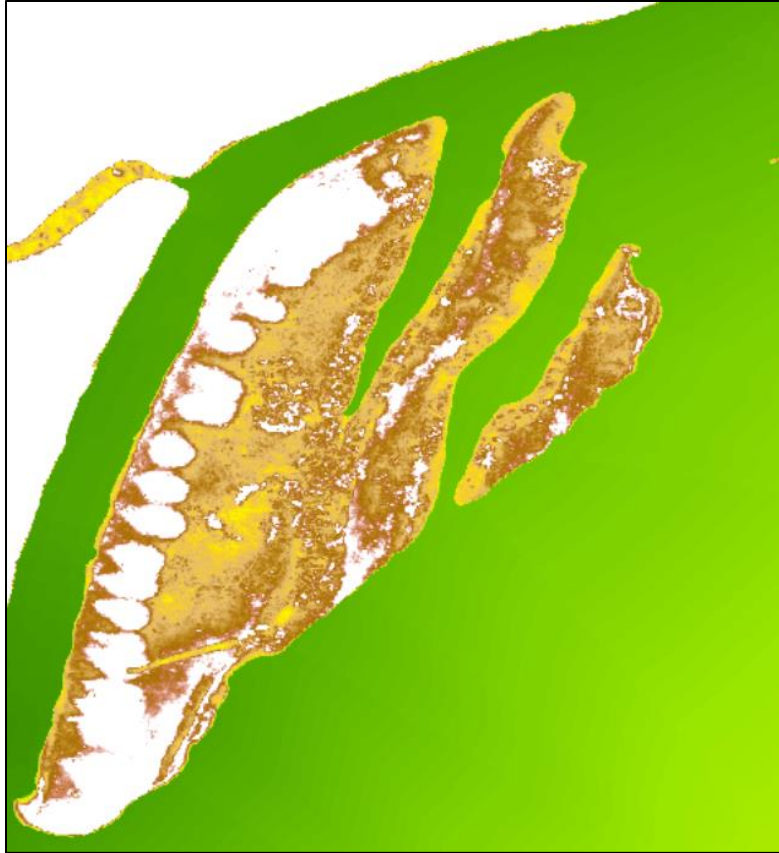
Figure 25. Delaware/Horseshoe Island: Areas above Maximum Monthly Average Lake Erie Level (White) and Areas below (Colors).

We also assessed island inundation frequency for each of the islands using lidar data and historical Lake Erie water levels. In Figure 22, Figure 23, Figure 24, and Figure 25, land areas in white would be above water when Lake Erie is at its highest recorded monthly average level (175.17 m, IGLD85), while those areas in color would be submerged. While vegetation, trees particularly, would extend above the water line, the land in the colored areas itself would be submerged. This aspect of island morphology may be an important component in determining habitat, especially for juvenile fish.

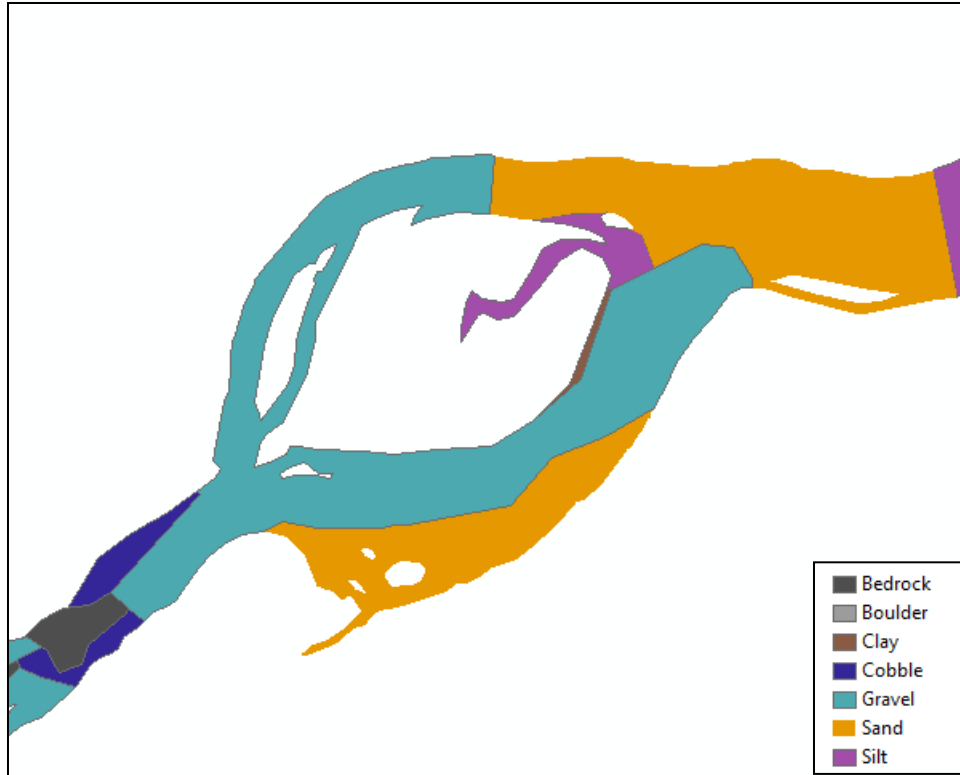
Figure 26. Bottom Substrate near Audubon Island (Source: Tucker, et al. 2020).

Substrate data was collected in the project areas through a combination of side scan sonar and ground-truthed substrate collections as described in Schmidt et al. 2020. Data from this study is available online (Tucker et al. 2020). Mapped substrates from this data are shown in Figure 26 and Figure 27, below.

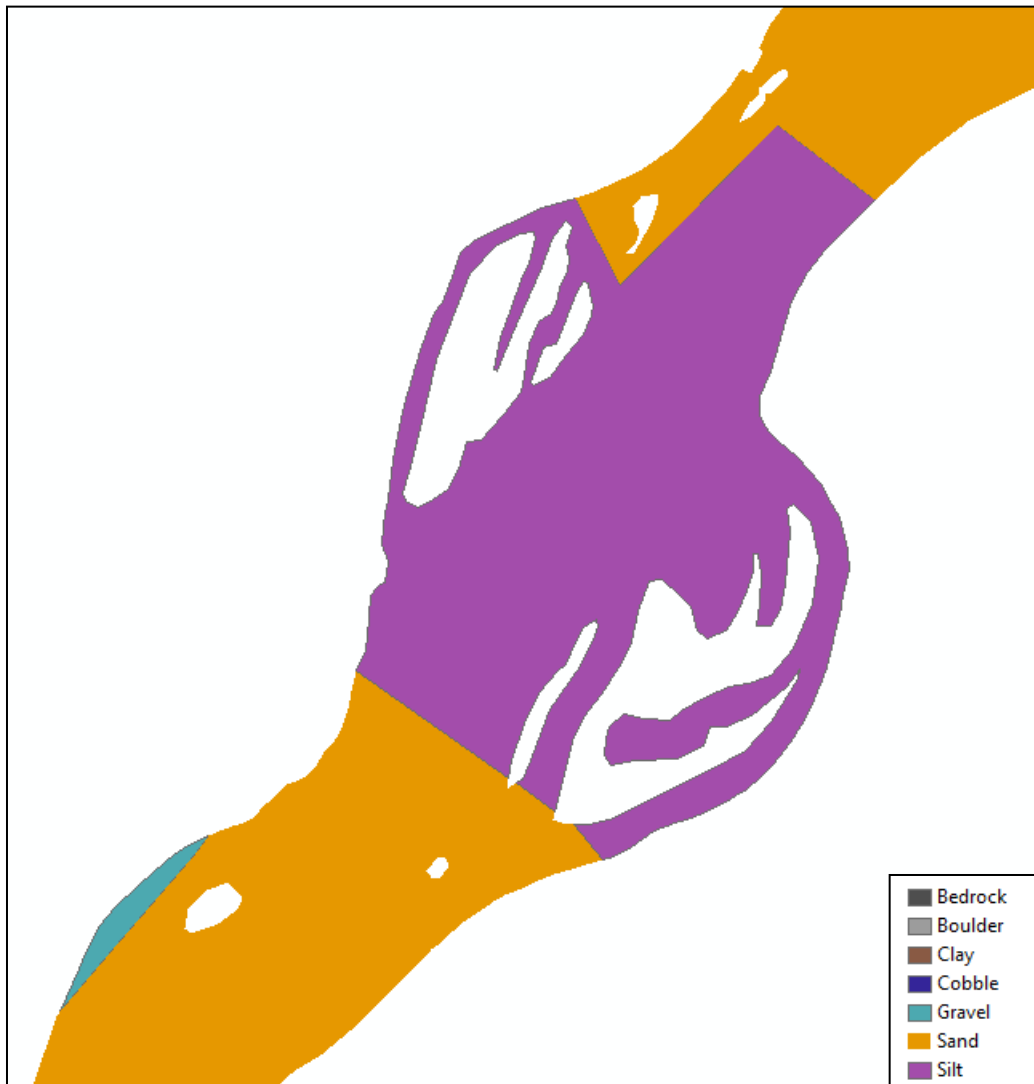
Figure 27. Bottom Substrate near Marengo, Grassy, and Delaware/Horseshoe Islands (Source: Tucker, et al. 2020).

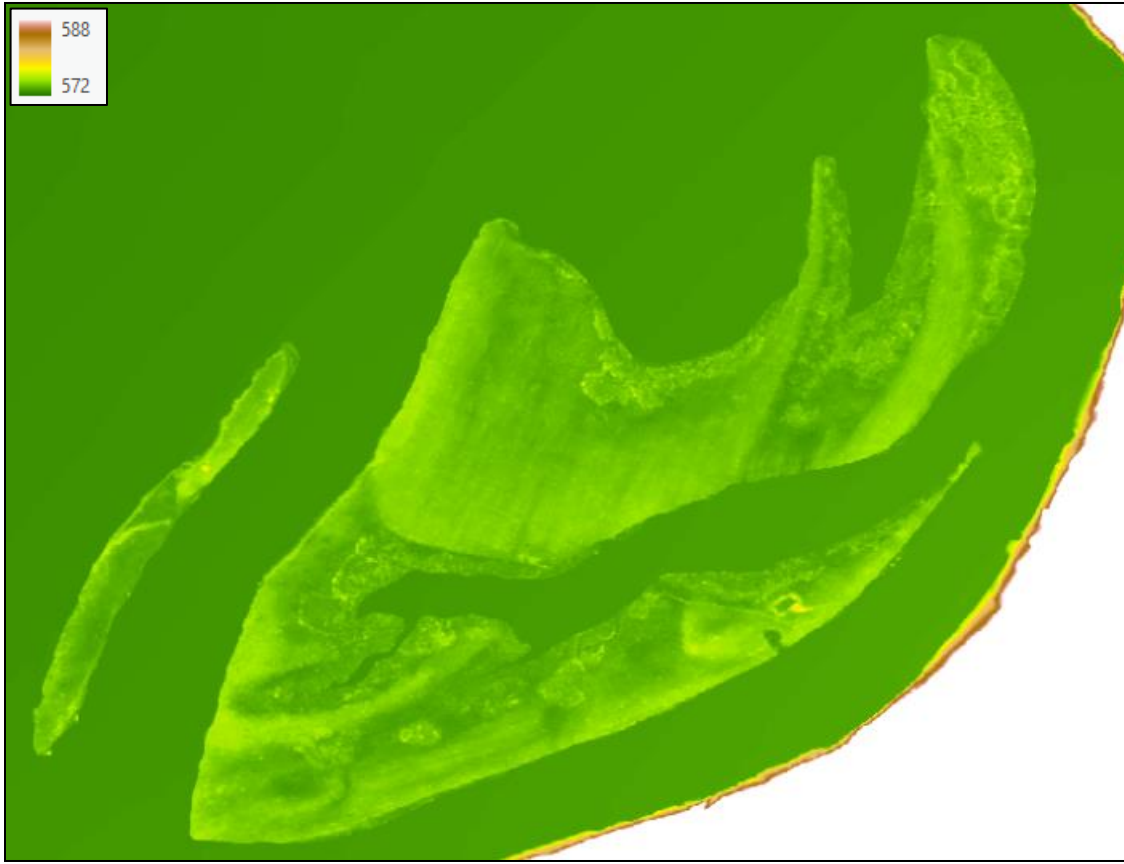
Figure 30. Lidar-Derived Elevation (ft) for Grassy Island.

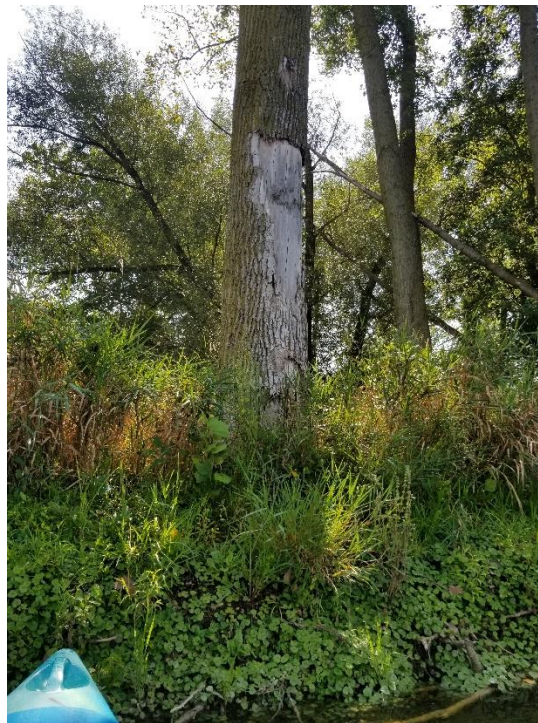
Figure 33. Ice Scar Evidence on a Tree on Audubon Island.

Ice impacts have been observed in the Lower Maumee River. In particular, the islands experienced an ice dam and ice scour event in 2015. During a recent kayak excursion, ice scar was evident on a tree on Audubon Island (see Figure 33).

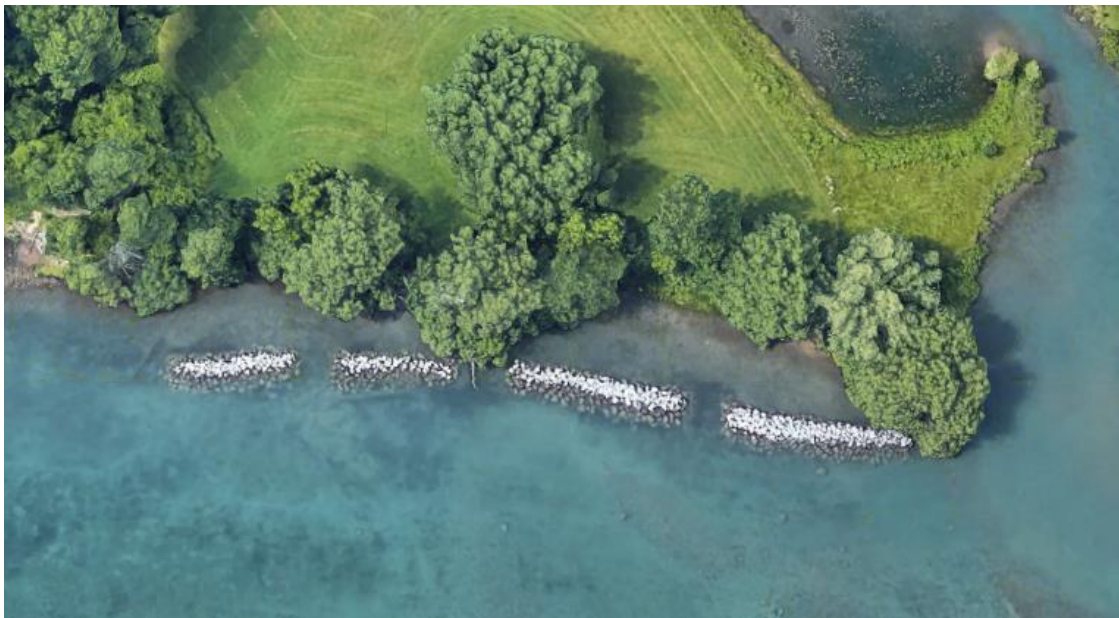
Figure 34: Detached rock reefs along the shoreline of Beaver Island, Grand Island, NY. Source, Google Earth 2021.

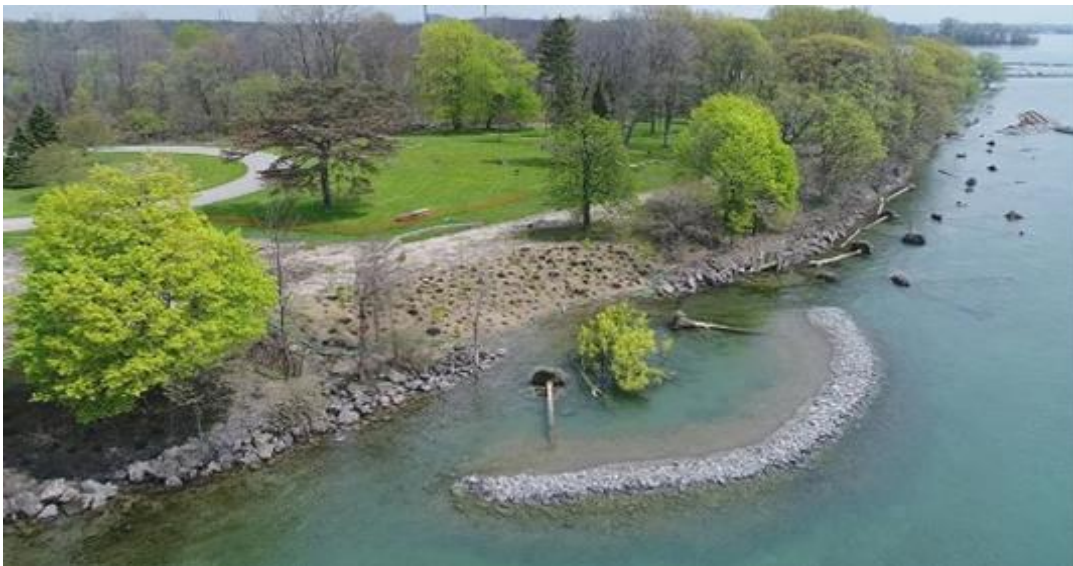
Figure 36: Rock reef and cabled logs/submerged trees. Source: Buffalo Niagara Riverkeeper.

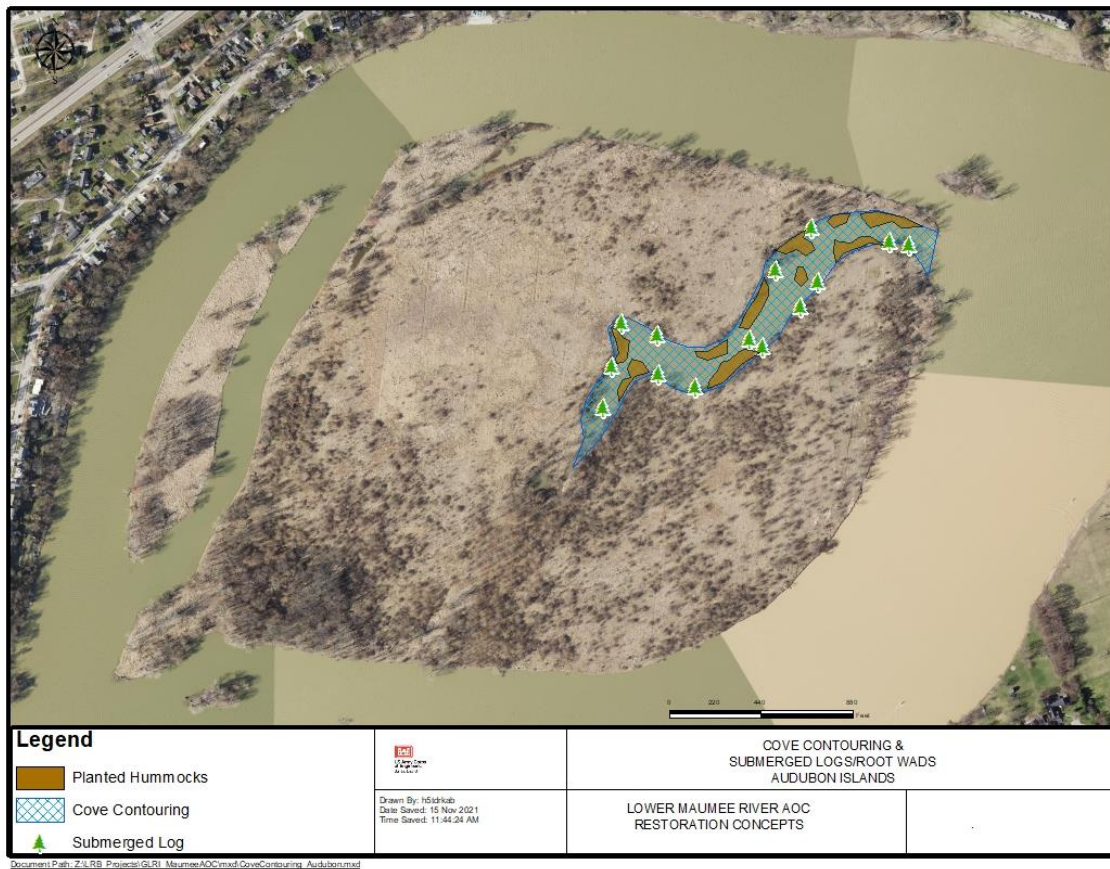
Figure 43: Cove contouring with planted hummocks and submerged trees/root wads.

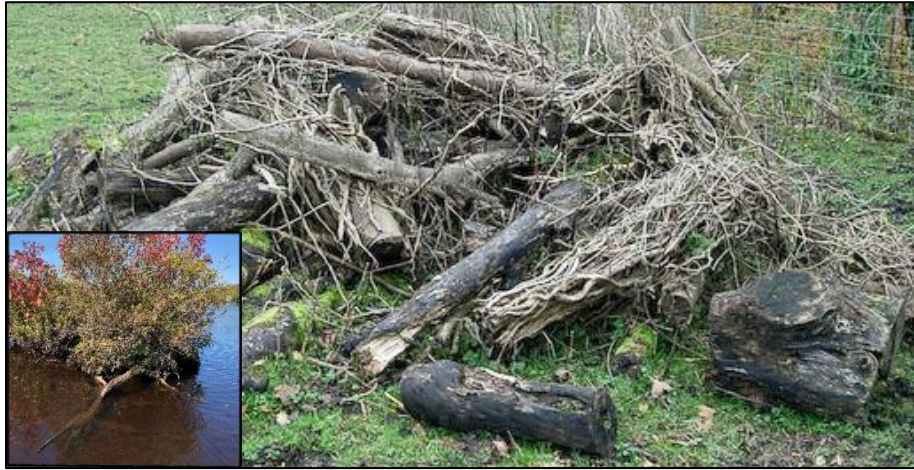
Figure 44: Logs used to contain dredged sediment. Logs would form the base of the planted hummock.

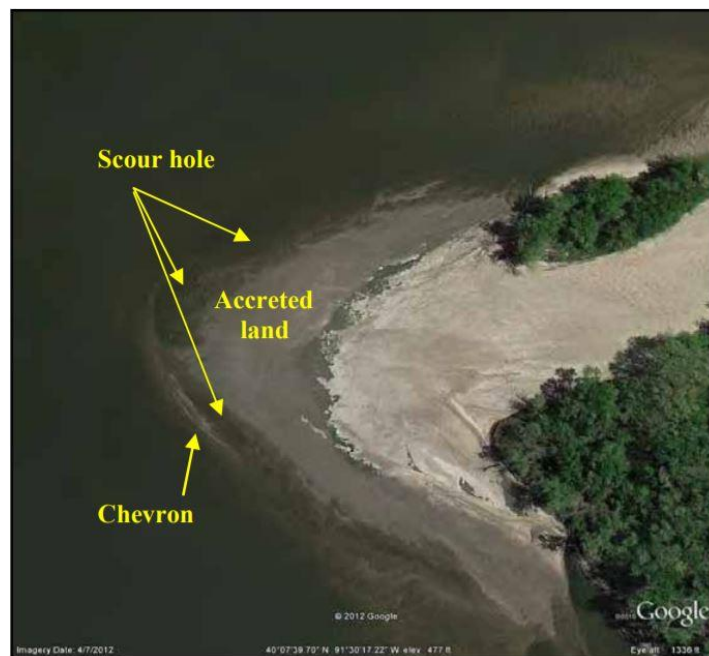
Figure 45: Chevron dike upstream of LaGrange Island in 2011. Source, Environmental Design Handbook, 2012.

Chevrons are dike structures designed as blunt nosed and arch shaped. The purpose of constructing a chevron dike is to use the energy of the river to redistribute flow and sediment. They are used to allow flow separation and create both channel deepening, side channel development, and middle bar formation (Figure 45). The placement of a chevron dike upstream of Marengo Island would act as a barrier to erosion from upstream flows, and sediment trapped downstream of the chevron would be redeposited along Marengo Island, thereby expanding the upstream end of Marengo Island.

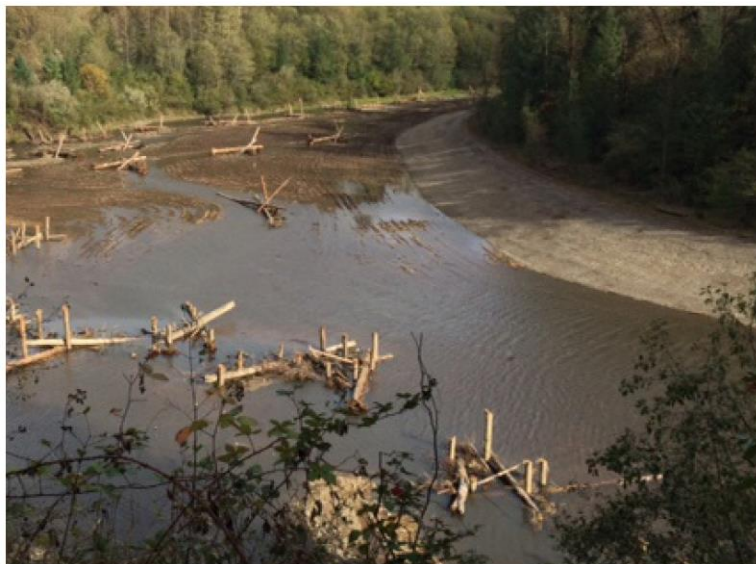
Figure 47: Woody habitat structure used in a large river system.

Woody habitat structures could be constructed as a standalone project, or in conjunction with the construction of the barrier islands. Woody habitat structures have been used in large river systems to control the flow of the river and to improve in-stream habitat complexity (Figure 47).

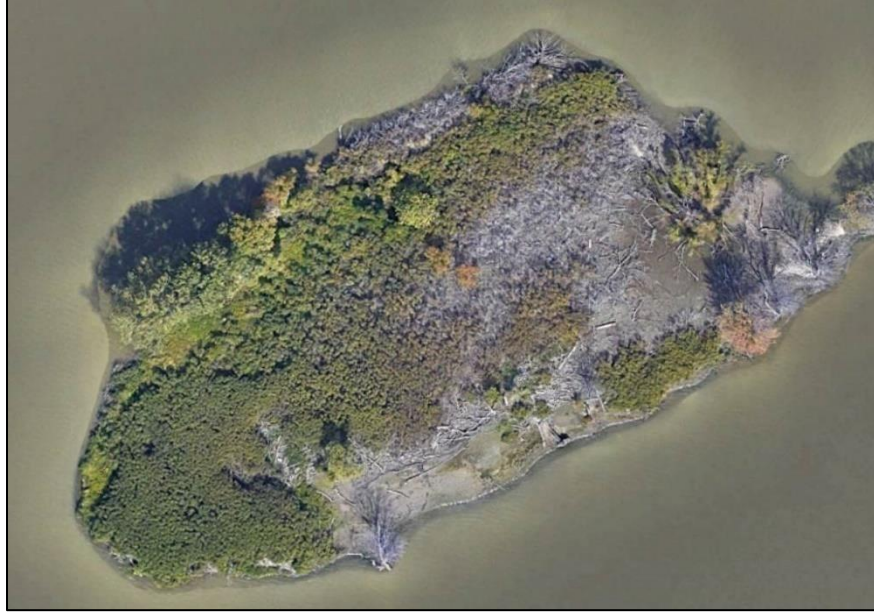
Figure 48: Google Earth image of Marengo Island from August 2020 showing substantial woody debris accumulation.

Based on visual and historic aerial image evidence, we assume that sufficient woody debris loads from upstream would be sufficient to populate the woody habitat structures with large woody debris (Figure 48).
